Rimkus Consulting Group, Inc.
Eight Greenway Plaza, Suite 500
Houston, TX 77046
(800) 580-3228 Telephone
(713) 623-4357 Facsimile

Re: RCG File No: 11009971
LLV Number: 0209452
VMF Location: 1530 Greensmark Drive in Houston, Texas
Subject: Final Report

Rimkus Consulting Group, Inc. was retained to examine LLV 0209452, VIN 1GBCS10E4M2908832. The fire occurred on June 13, 2016 at around 12:30 P.M. the operator of the vehicle at the time of the fire, was unavailable for interview but reportedly stated the vehicle's engine died while delivering mail on his route and backfired during subsequent attempts to restart it. Soon thereafter, smoke was observed from beneath the hood as well as flames.

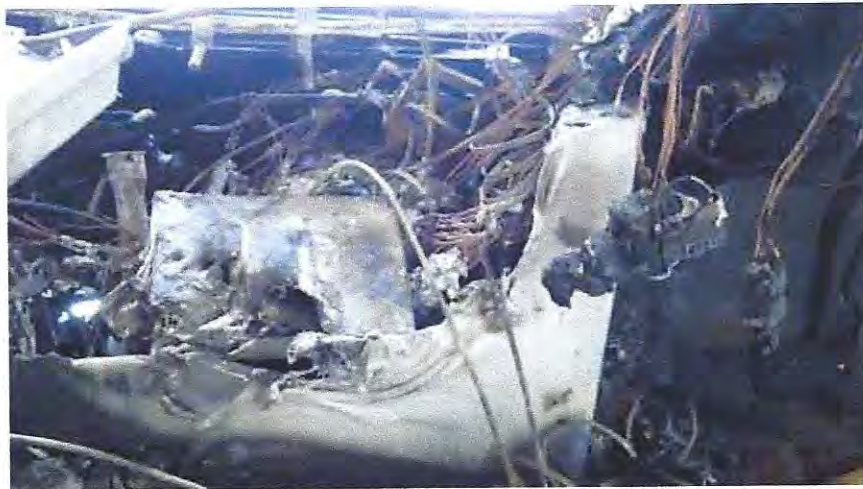
The examination of the fire damage revealed that the fire occurred in the cowl area between the dash and firewall. The fire extended up from this area and spread to the passenger and engine compartments. The electronic control module (ECM) was severely damaged. The ECM is mounted below the interior plastic vent system. The ECM failed which created arcing which ignited the plastic vent system. The failure was caused by excessive current from the battery to the ECM causing heat to ignite the plastic.

1. The area of origin for this fire was determined to be the cowl area between the passenger and engine compartments.
2. The point of origin was determined to be the electronic control module.
3. The failure of the electronic control module caused it to produce arcs and ignite available combustibles.
4. After a complete investigation of this fire loss, Trident has determined this fire to be a mechanical failure.

View of point of origin.

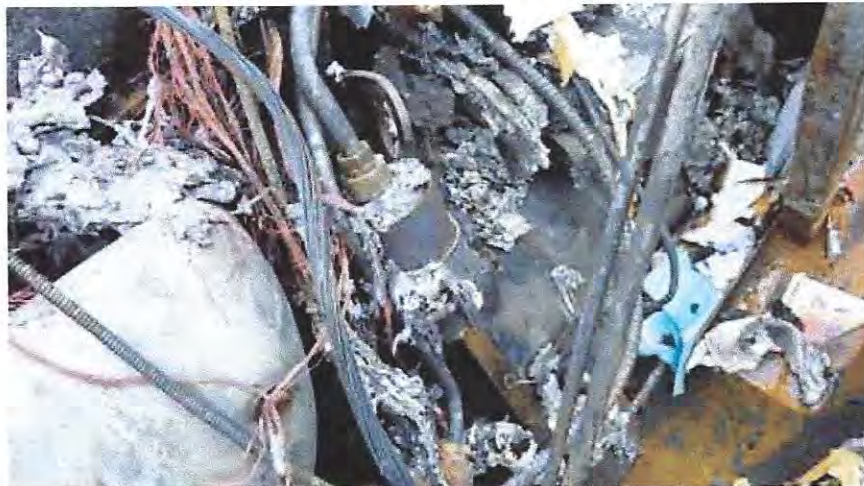
Trident has examined the LLV no. 9217781 and the associated maintenance records. The origin of the fire was found to be at the fuel filter. Trident's observation that the lower connection on the filter displayed a clean burn, the fuel line not being connected to the filter, and no evidence of the connection being melted to the filter connector. This is an indicator that the noise heard by the carrier was the fuel line becoming dislodged from the filter. This would have caused the vehicle to stall. The attempts to restart the vehicle would have pumped raw gasoline directly onto the manifold causing ignition of the gasoline vapors.

1. The origin of the fire was at the fuel filter located on the left side of the engine.
2. The first fuel ignited would have been the gasoline pumped from the filter during restart attempts.
3. The evidence of the clean burn and lack of remains of the lower fuel line indicate the lower fuel line became disconnected from the fuel filter. The probable cause being improper installation of the fuel line.

View of fuel filter showing lower line not in place.

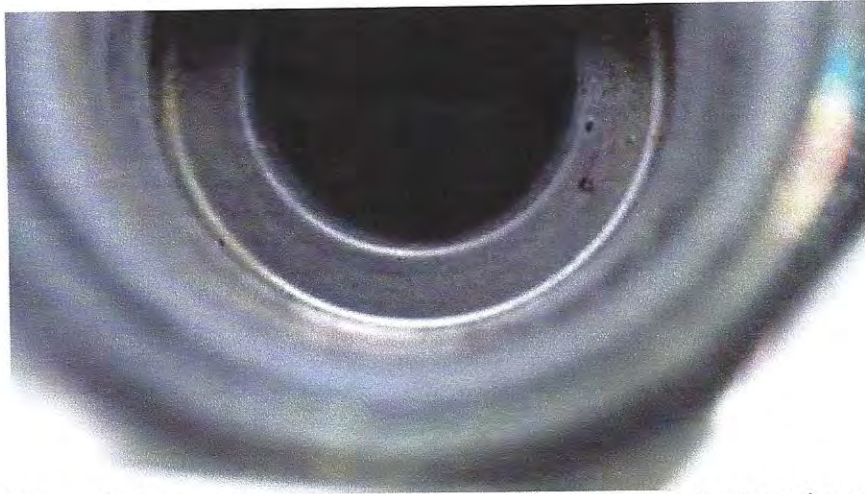
View of interior of lower connection on fuel filter; note clean burn.

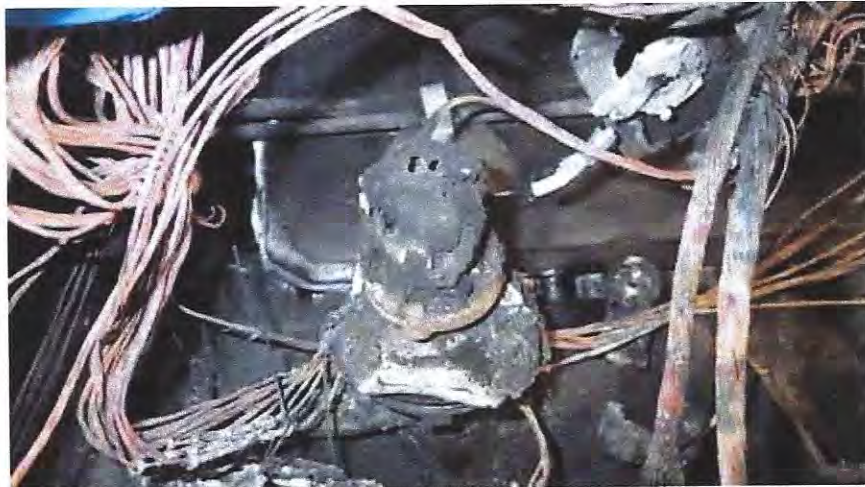
The examination of the fire damage revealed a fire occurred in the engine compartment. The fire extended up from the distributor cap and into the passenger and engine compartments. The distributor and its components were severely damaged. The distributor failed which produced arcing that ignited nearby combustibles. This failure was caused by excessive current causing heat to ignite the plastic and wire insulation.

1. The area of origin for this fire was determined to be the engine compartment.
2. The point of origin was determined to be the distributor.
3. The failure of the distributor caused it to produce arcs and ignite available combustibles.
4. After a complete investigation of this fire loss, Trident has determined this fire to be a mechanical failure.

View of the point of origin.

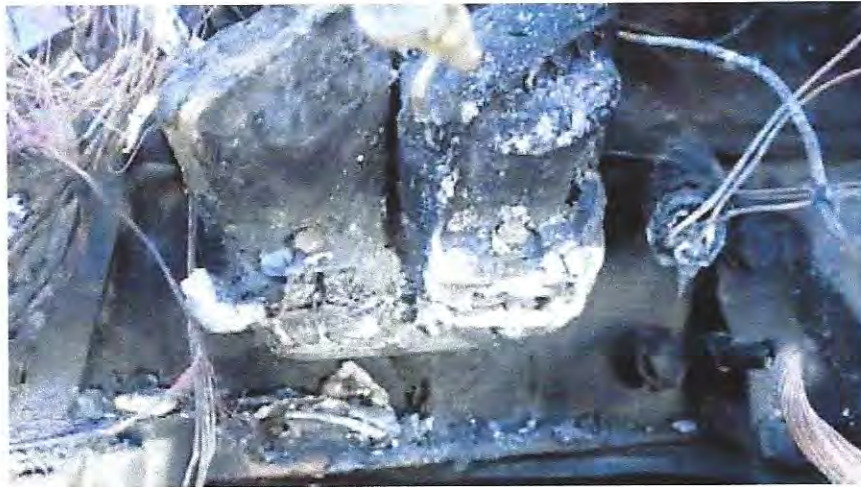
The examination of the fire damage revealed a fire occurred in the engine compartment. The fire extended up from the distributorless ignition and into the engine and passenger compartments. The distributorless ignition system created excessive heat causing the coil pack to overheat. The overheated coil pack ignited the plastic housing of the distributorless ignition and caused the fire. The fire damaged nearby spark plug wires and other wiring.

1. The area of origin for this fire was determined to be the engine compartment.
2. The point of origin was determined to be the distributorless ignition system.
3. The failure of the distributorless ignition system caused it to produce an over current/excessive heat situation.
4. The failure of the distributorless ignition caused it to produce arcs and ignite available combustibles.
5. After a complete investigation of this fire loss, Trident has determined this fire to be a mechanical failure.

View of the point of origin.

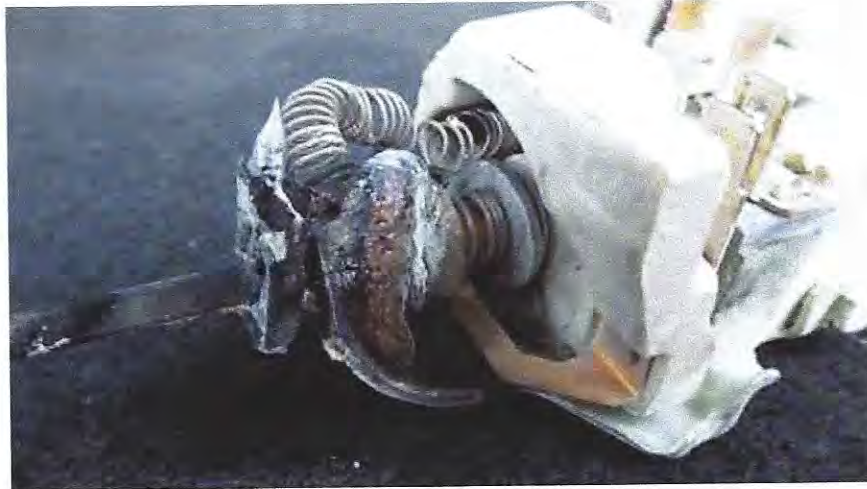
The fire damage to this vehicle was confined to the area around the headlight switch. The vehicle wiring was examined and determined to be in good condition with the exception of the exposed wiring in the engine compartment being covered with grease and grime. The examination of the headlight switch may determine if the breaker within the switch actuated.

1. The origin of this fire was determined to be at the headlight switch located on the left side of the dash in the driver compartment.
2. The associated wiring for the headlight switch was ruled out as a cause of the fire.
3. The point of origin for this fire was determined to be the headlight switch itself.
4. The nature of the failure for this switch is to be determined.

View of damage to switch post.

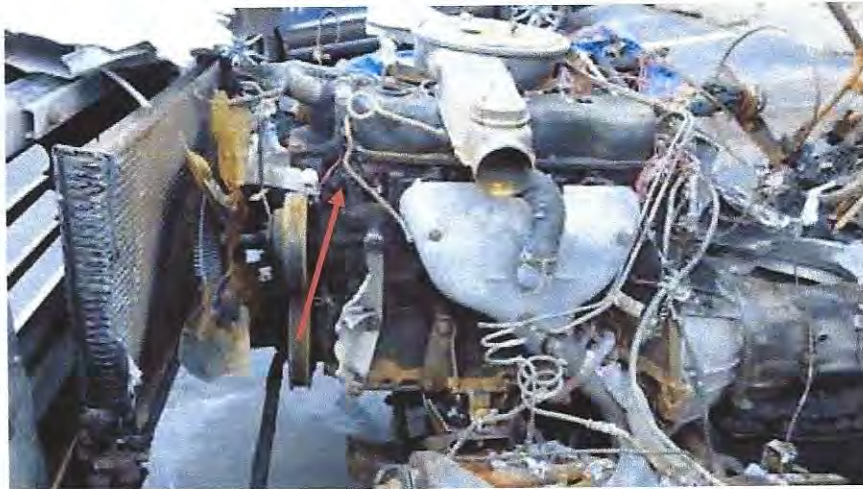
The examination of the fire damage revealed the fire occurred in the engine compartment. The fire extended from the exhaust manifold and into the engine and passenger compartments. The fuel filter was mounted on the front left side of the engine. The supply end of the filter faced the rear of the engine directly above the exhaust manifold. The fuel filter's supply end fitting was loose. The LLV had an odor of gasoline which was coming from the fuel filter. The leaking gasoline came in contact with the heated exhaust manifold causing a hot surface ignition and caused the fire.

1. The area of origin for this fire was determined to be the engine compartment.
2. The point of origins heat source was determined to be the exhaust manifold.
3. The leak from the fuel filter caused gasoline to spray on to the hot exhaust manifold.
4. The gasoline leaking or sprayed onto the heated exhaust manifold caused a hot surface ignition and ignited available combustibles.
5. After a complete investigation of this fire loss, Trident has determined this fire to be a mechanical failure.

View of the area where fuel filter was located.

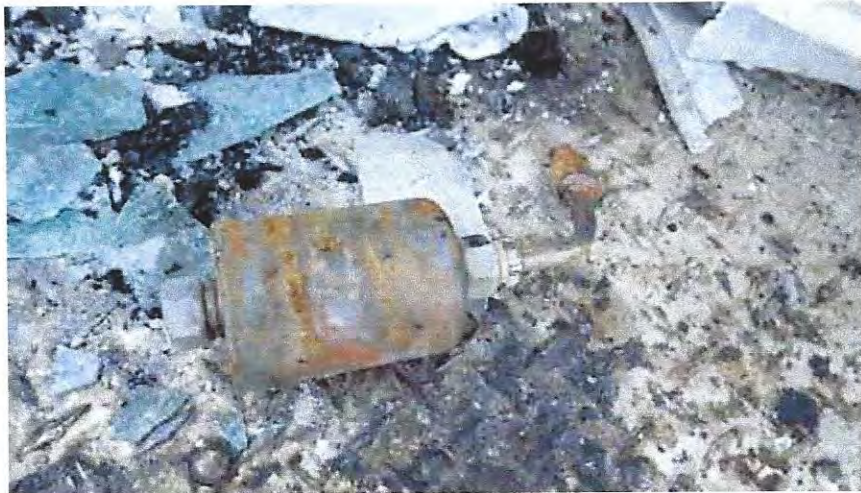
View of fire patterns on fuel filter.

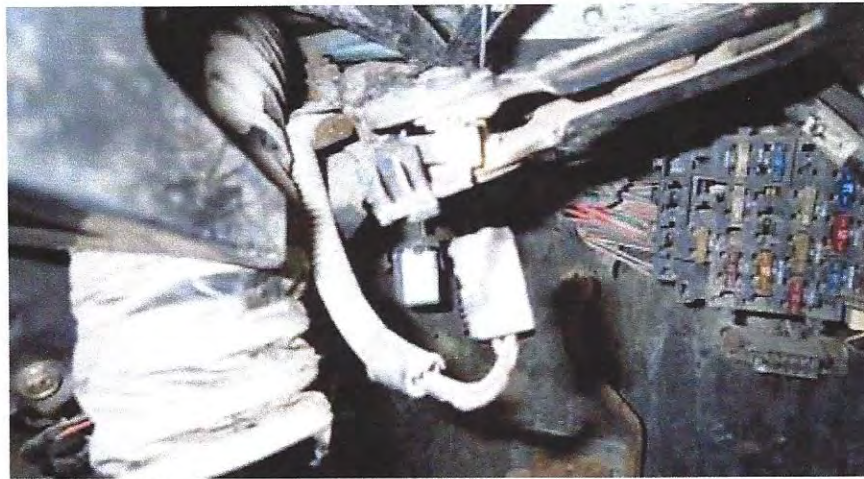
The fire involving LLV no. 2210021 was confined to the wire connection at the emergency brake. The fire had two potential sources of ignition. The first being the heater duct that was placed in close proximity to the connection at the emergency brake. The placement of the duct, that contained a wire support system wrapped in cloth, may have come in contact with exposed wire at the connection. The second possible cause being the failure at the battery cable that was associated with the ground wire failure. This failure may have caused an increase in amperage throughout the system and the connection at the emergency brake was the weakest point. The installation of the battery cable comes into question due to the close proximity of the speedometer cable and the wear point on the wire. This was found at the point it passed through the secure point located on the right side of the engine. The fact that there was no evidence of fire at the battery wire could be associated with the wire being new. The ignition temperature would be higher than if it had been a wire that had experienced thermal break down over an extended period of time. The other possibility is that there were two separate incidents with no possible determination if they are related.

1. The point of origin for this event is the connector switch at the emergency brake.
2. The finding of the electrical activity on the main battery cable and speedometer cable may have been the cause of this fire, with the failure occurring at the electrical connection at the emergency brake, or there may be two separate issues with the electrical system.
3. With the above stated finding, Trident will hold this fire as undetermined in nature. It is not possible to determine which event occurred first or if there were two separate incidents.

View of fire damage to wire connector at emergency brake.

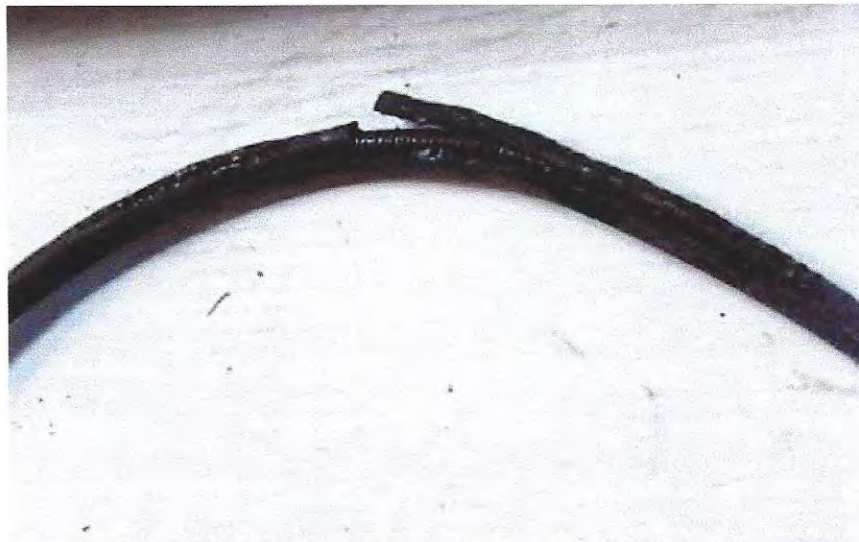
View of electrical activity on speedometer cable.

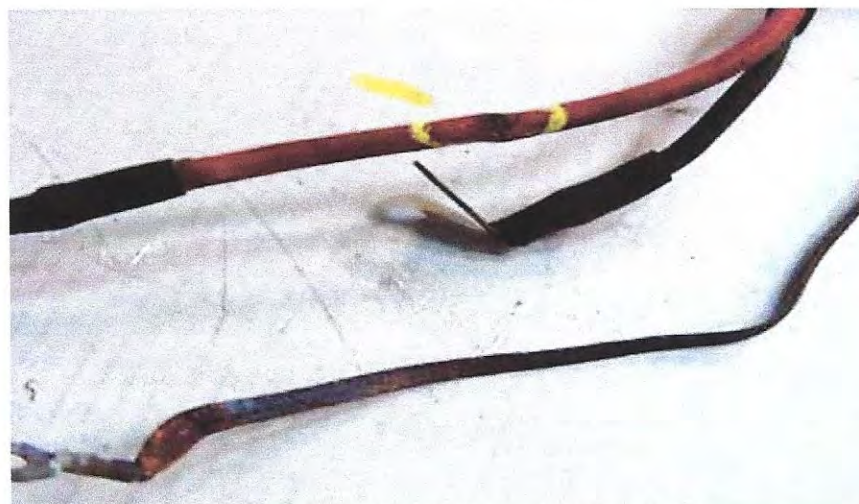
View of electrical activity on battery cable.

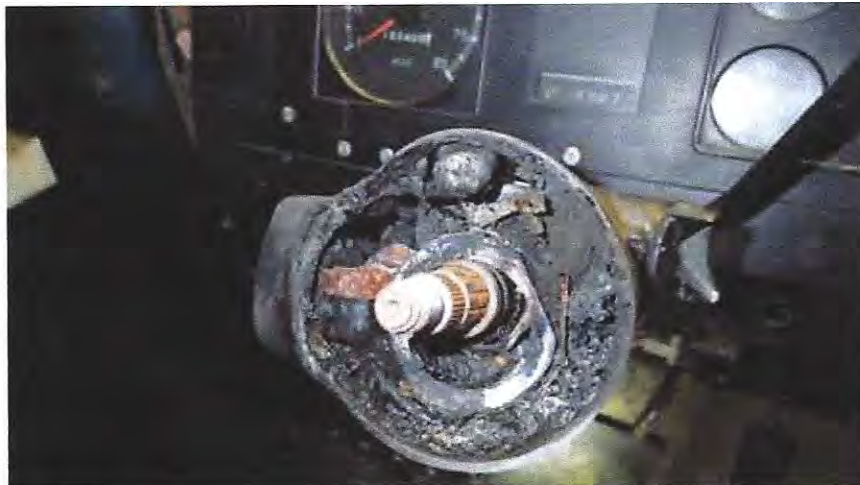
1. The area of origin for this fire was located at the steering wheel.
2. The point of origin for this fire was the turn signal switch, located at the center of the steering wheel.
3. The first fuel ignited would have been the insulation on the available wiring.
4. The cause of this fire is being held as undetermined, due to the fact that the initial failure could not be determined due to the turn signal cancel spring not being in place.

View showing dis-assembly of steering column.

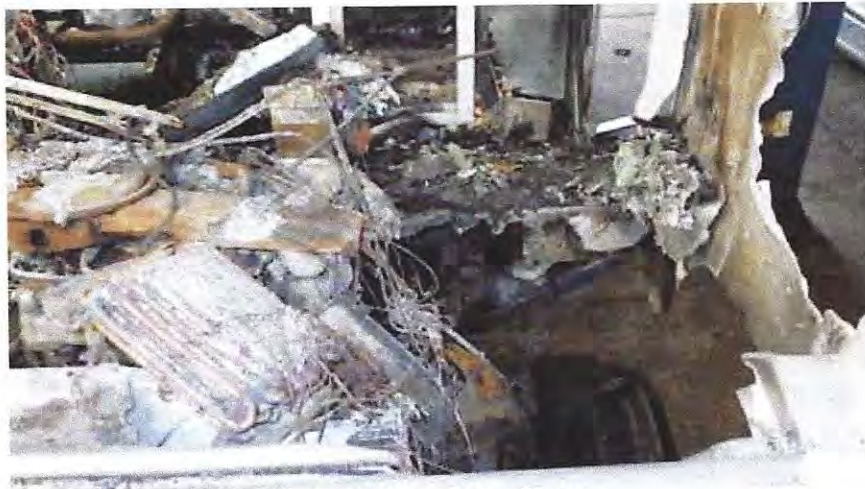
The examination of the fire damage revealed a fire occurred in the engine compartment, specifically the left side. Due to the flammability of the engine fluids and available fuels, combined with an extended extinguishment time, the fire consumed all available combustibles.

1. The area of origin for this fire was determined to be the engine compartment, specifically the left side of the engine.
2. The point of origin could not be determined due to severe fire damage and lack of information.
3. After a complete investigation of this fire loss, Trident has determined this fire to be undetermined in nature.

View of the point of origin.

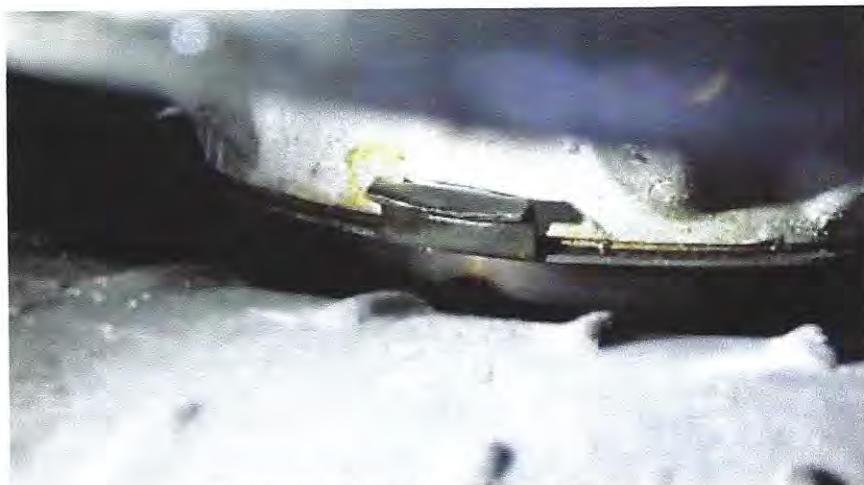
All burn patterns and fire damage revealed that the fire progressed from the engine-transmission separator plate. The damage is an indicator of the transmission pump failing. This failure is possibly the result of the vehicle's transmission being alternated switched back and forth from reverse to drive in an attempt to rock the vehicle out of the snow and ice. Trident saw no record of transmission work being performed on the vehicle in the records it received.

1. The area of origin for this fire is the transmission.
2. The point of origin for this fire is at the engine-transmission separator plate.
3. This failure would have resulted in the transmission fluid being atomized out onto the exhaust causing immediate ignition of the fluid.

Close up view of Transmission seal.

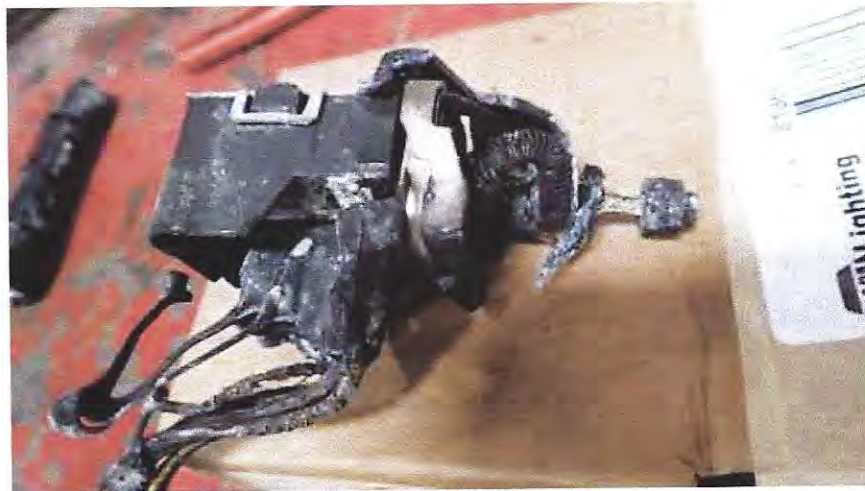
As previously discussed, the failure occurred in the rheostat of the headlight switch. A possible cause for this is a short circuit in the dash lighting. A short in the horn/turn signal assembly is a possible cause as well.

1. The fire originated in the rheostat of the headlight switch.
2. There are no records of recent replacement of this switch.
3. The probable causes for this occurrence are a short circuit within the dash lighting, turn signal assembly, and associated wiring.

View of head light switch.

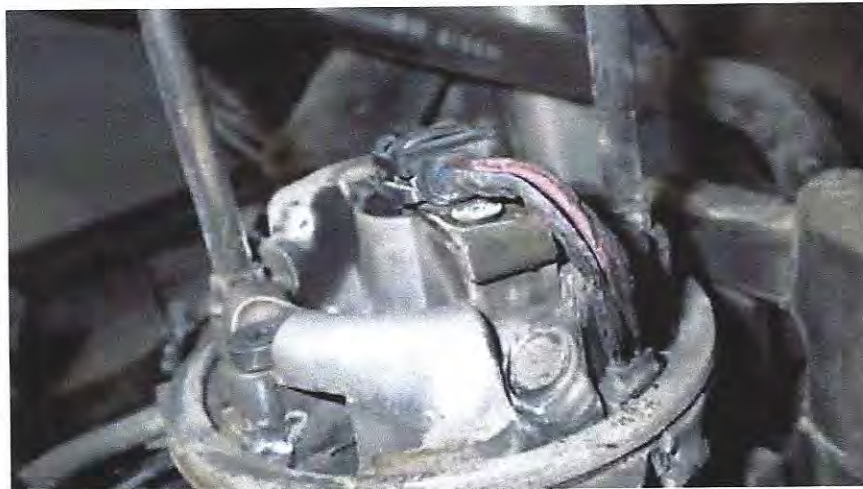
The examination of the fire damage revealed a fire occurred in the engine compartment. The fire extended from the carburetor and into the engine compartment. The carburetor had fuel moving through the system when the "back fire" occurred, igniting the unburned fuel, causing a quick flame. The fire damaged a nearby wire loom and wiring, along with soot damage to the hood and cowl areas.

1. The area of origin for this fire was determined to be the engine compartment.
2. The point of origin was determined to be the carburetor.
3. The failure of the engine to run properly caused a back fire, which produced a flame that ignited nearby fuel.
4. After a complete investigation of this fire loss, Trident has determined this fire to be a mechanical failure.

View of the point of origin and patterns.

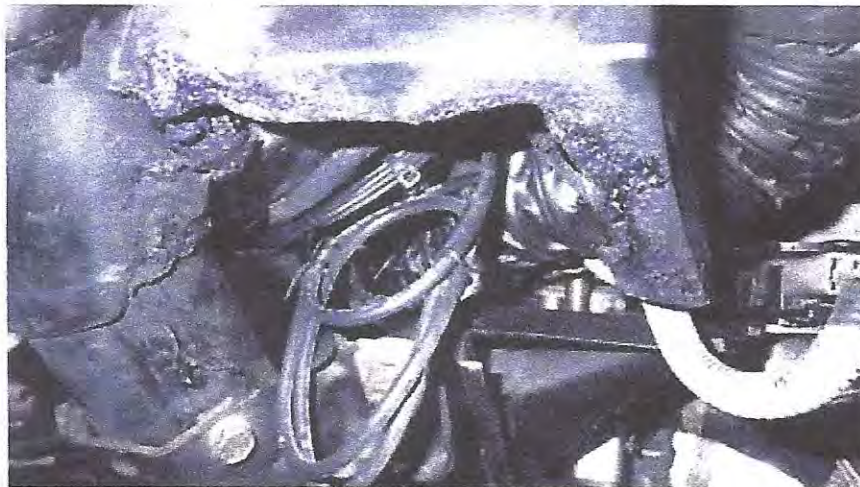
The examination of the fire damage revealed, a fire occurred in the passenger compartment. The fire extended up from the lower right side of the dash, causing damage to the instrument cluster. The instrument cluster suffered heat and smoke damage. The fire damaged an area of the dash, in which no competent ignition sources were found. No evidence was found that indicates the fire was intentionally set, however, this cannot be completely ruled out. Human error or involvement with this fire cannot be completely ruled out. One scenario or hypothesis of a competent ignition source would be a torch flame. If the torch was on and sat on the floor of the vehicle, after the operator was distracted, it would have caused this damage. The only employee who used a competent ignition source was custodial worker, [REDACTED]-[REDACTED]. [REDACTED] called in sick on both days interviews were attempted.

1. The area of origin for this fire was determined to be the passenger compartment.
2. The point of origin was determined to be the right lower dash area.
3. After a complete investigation of this fire loss, and the lack of information from the Custodial worker, Trident has determined this fire to be undetermined in nature.

View of point of origin.

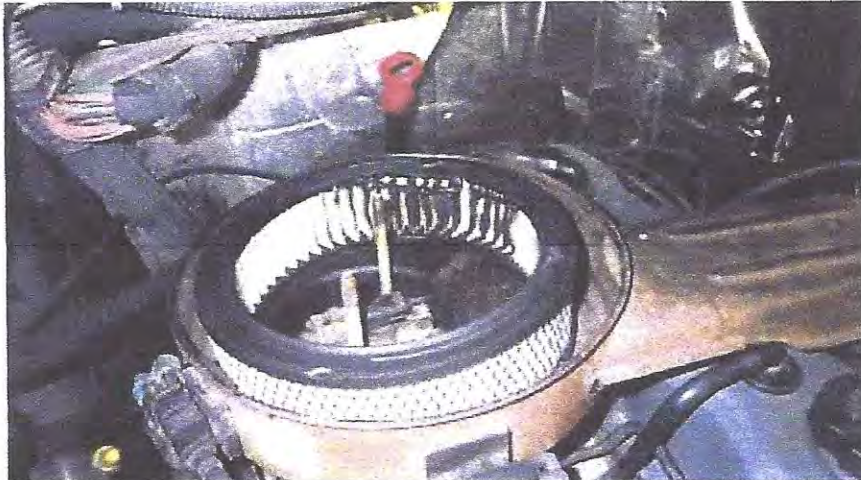
With the report of [REDACTED] at the location of the first fire scene and the fire damage localized at the air cleaner, this fire is possibly the result of a failure of the crank sensor. There was also no record found of recent crank sensor replacement.

1. The origin of this fire is within the air cleaner assembly.
2. The probable cause is a failure of the crank sensor causing the reported back fire and inability to start the vehicle.

View of air cleaner damage.

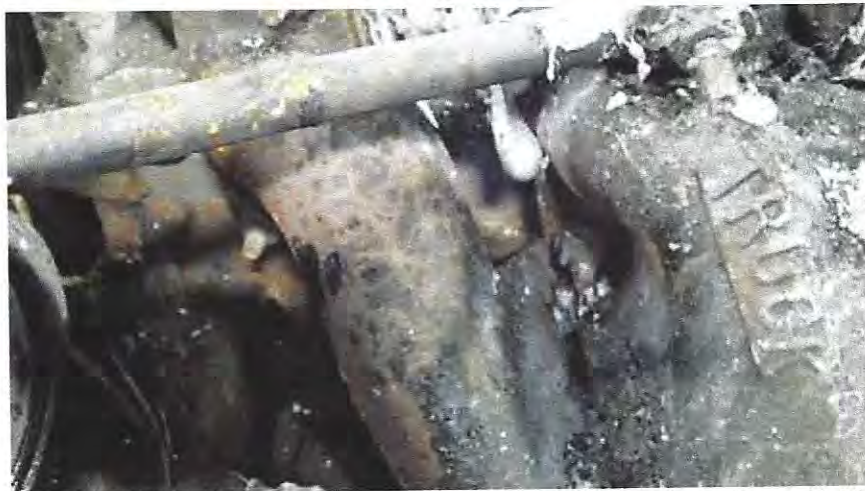
The examination of the fire damage revealed a fire occurred in the engine compartment. The fire extended from the exhaust manifold and into the engine and passenger compartments. Witness accounts report hearing a noise and losing power steering. Shortly after, the witness reported seeing white smoke. The power steering pump/line sprayed/atomized fluid over the heated exhaust manifold, causing a hot surface ignition and creating the fire.

1. The area of origin for this fire was determined to be the engine compartment.
2. The point of origin was determined to be the exhaust manifold.
3. A leak from the power steering pump caused power steering fluid to spray on to the hot exhaust manifold.
4. The fluid leaking or sprayed onto the heated exhaust manifold caused a hot surface ignition and ignite available combustibles.
5. After a complete investigation of this fire loss, Trident has determined this fire to be a mechanical failure.

View of the point of origin and oily deposits on exhaust manifold.

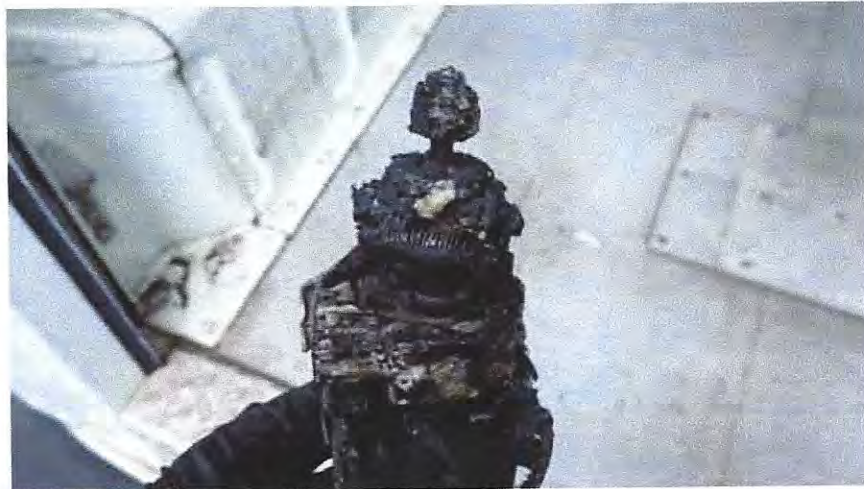
As previously discussed, the failure occurred in the rheostat of the headlight switch. The possible causes for this to occur are a short circuit in the dash lighting and, possibly a short in the horn/turn signal assembly.

1. The fire originated in the rheostat of the headlight switch.
2. There are no records of recent replacement of this switch.
3. The probable causes for this occurrence are a short circuit within the dash lighting, turn signal assembly and associated wiring.

View of headlight switch.

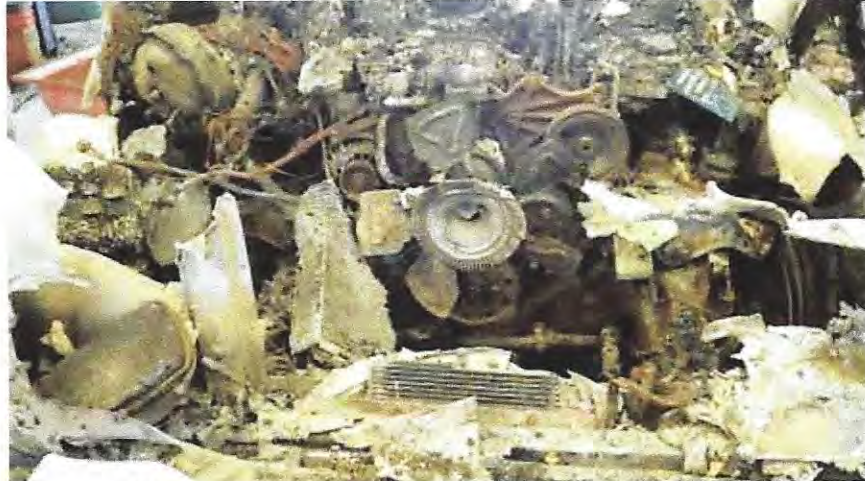
The examination of the fire damage revealed a fire occurred in the engine compartment, specifically the left side. Due to the flammability of the engine fluids and available fuels, combined with an extended extinguishment time, the fire consumed all available combustibles.

1. The area of origin for this fire was determined to be the engine compartment.
2. The point of origin could not be determined, due to the lack of information and severe fire damage.
3. After a complete investigation of this fire loss, Trident has determined this fire to be undetermined in nature.

View of the engine compartment fire patterns.

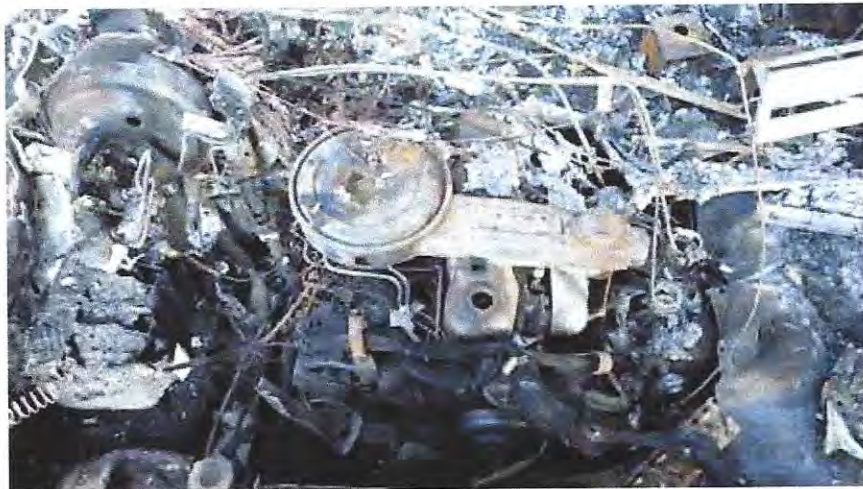
The examination of the fire damage revealed a fire occurred in the engine compartment, specifically underneath and the left side. Due to the flammability of the engine fluids and available fuels, combined with an extended extinguishment time, the fire consumed all available combustibles.

1. The area of origin for this fire was determined to be the engine compartment.
2. The point of origin could not be determined due to the lack of information and severe fire damage.
3. After a complete investigation of this fire loss, Trident has determined this fire to be undetermined in nature.

View of the fire damage to engine compartment.

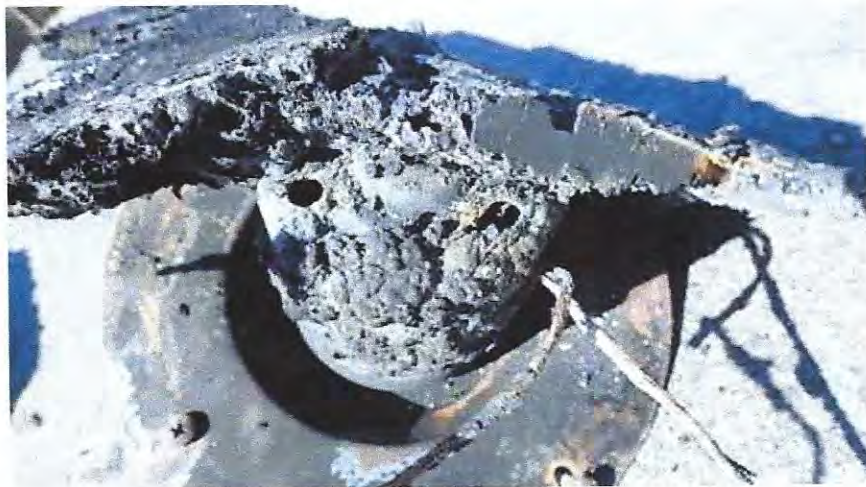
Investigation of this fire determined the point of origin to be the blower motor however, the initial failure within the motor cannot be determined due to the complete destruction by fire of the interior workings.

1. The origin of this fire was at the left side of the bulkhead.
2. The point of origin for this fire is located at the heater blower.
3. The cause of this fire is undetermined due to the complete destruction of the blower motor by fire.

View of back side of blower.

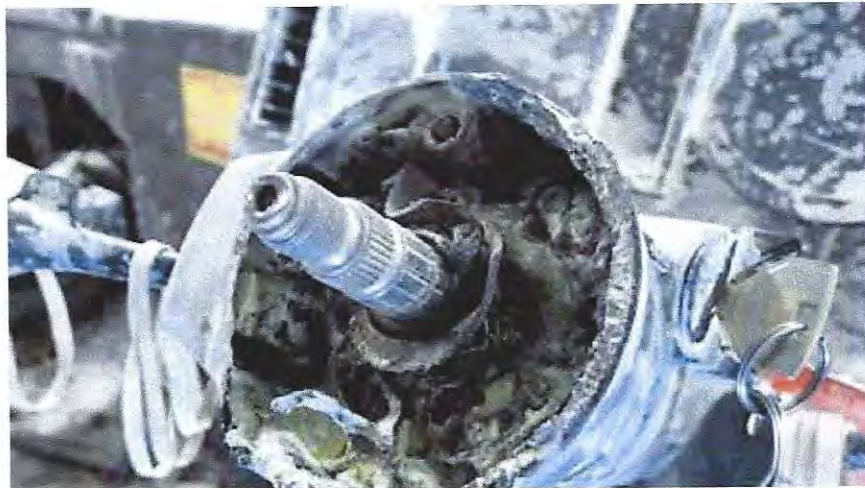
The origin of this fire was determined to be at the turn signal switch assembly within the steering column. The extensive damage to this assembly prevented a complete examination of the unit. The first failure within this unit could not be determined.

1. The origin of this fire was within the turn signal switch assembly.
2. The right turn cancel spring was found to not be in place with the most extensive damage at the point it was found.
3. With the complete destruction by fire of the unit and the inability to remove the unit for examination, Trident will hold this fire as undetermined in nature with the first failure within the unit not found.

View of turn signal switch remains.

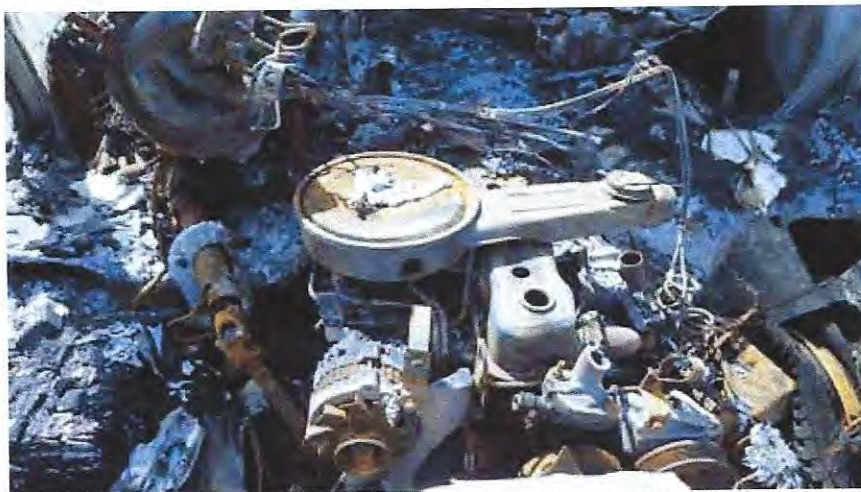
The examination of the fire damage revealed a fire occurred in the engine compartment, specifically underneath and the left side. Due to the flammability/combustibility of the engine fluids and available fuels, combined with an extended extinguishment time, the fire consumed all available combustibles.

1. The area of origin for this fire was determined to be the engine compartment.
2. The point of origin could not be determined do to the lack of information and severe fire damage.
3. After a complete investigation of this fire loss, Trident has determined this fire to be undetermined in nature.

View of the fire damage to engine compartment.

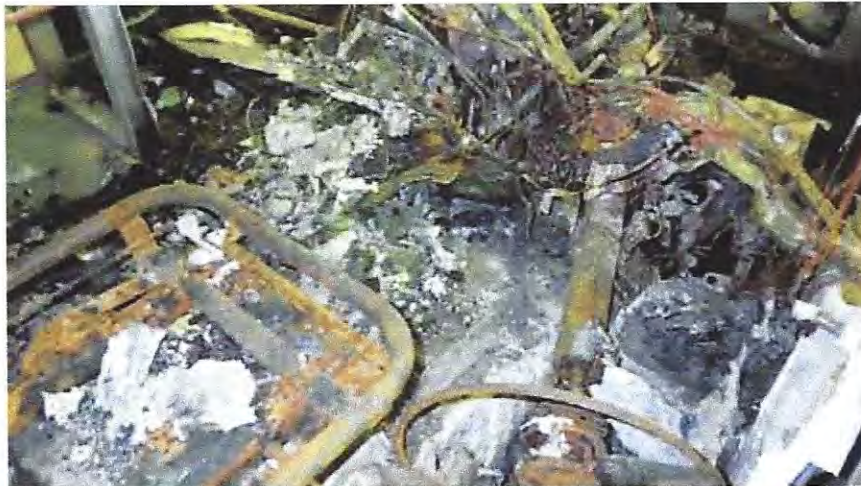
After a complete examination of this vehicle and components and interview of the operator, Trident has learned that the fire extended from the operator compartment into the engine compartment. With the operator observations, the origin of this fire is found to be the interior of the vehicle under the dash. All wiring and components in this area are extensively damaged by fire, prohibiting the determination of the exact first failure. The most probable cause of this fire is electrical in nature.

1. The origin of this fire is under the dash.
2. The exact point of origin under the dash cannot be determined.
3. The most probable cause for this fire is electrical in nature.

View of dash and steering column area.

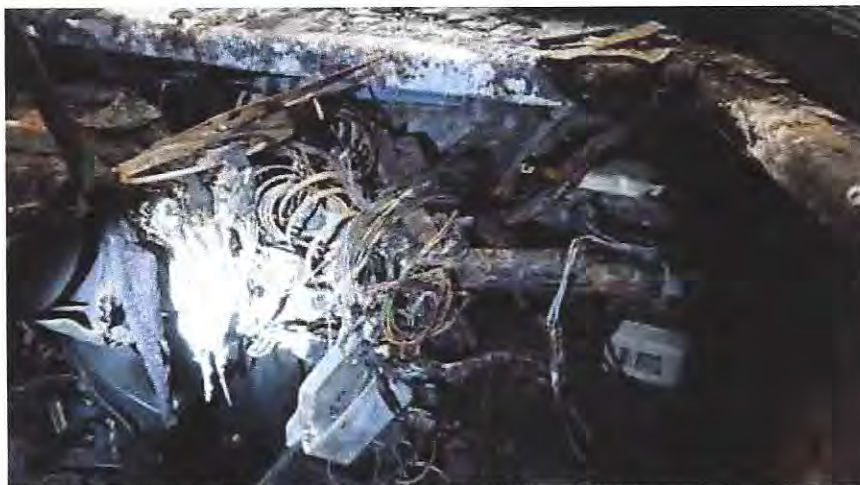
The examination of the fire damage revealed wires burned in four separate locations of the vehicle. Three of the locations were under the hood involving ground wires. The fourth location was the positive connection to the starter. The positive cable became disconnected from the starter and made contact with the frame. The frame of the vehicle was grounded. All locations indicated the wires and or fuse connection overheated and caused a fire. Determination of the cause of these failures was not possible at the time of this writing. These failures may have been caused by excessive current within associated electrical components and/or wiring.

1. The area of origin for this fire was determined to be the passenger compartment.
2. Four separate fire events occurred within this vehicle.
3. It is possible that all four of the events could be associated with a grounding problem.
4. After a complete investigation of this fire loss, Trident has determined this fire to be undetermined in nature.
5. Any further information found involving this type of problem in other vehicles may lead to information as to the origin and cause of this fire.

View of damage near fuse block.

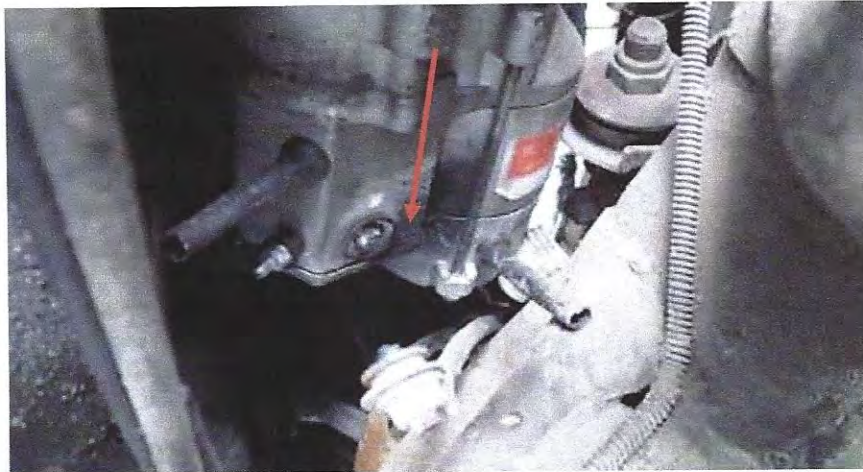
View of the starter electrical arc.

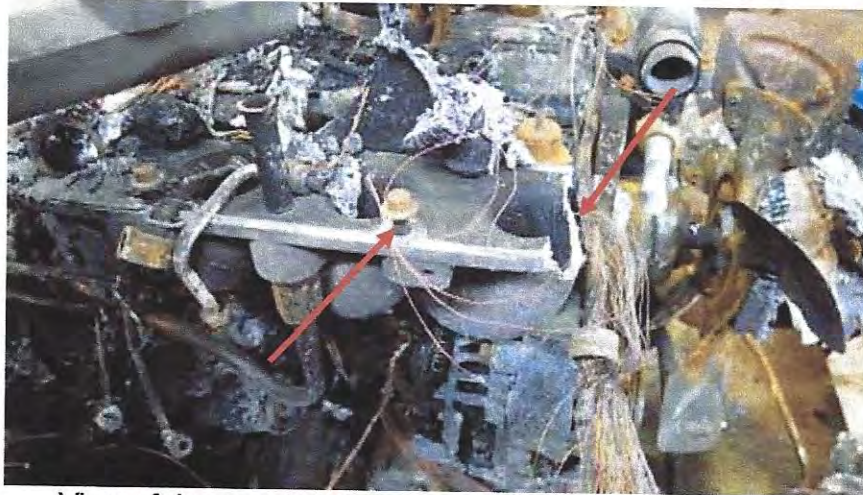
After a complete investigation of this fire, all fire damage and burn patterns indicate the fire originated on the right side top of the engine. The top of the manifold showed evidence of being torn away with the front of the manifold showing evidence of being broken away. This damage could possibly have resulted in the manifold having been damaged previously and the resulting backfiring of the vehicle finally dislodged it. This backfiring issue had been addressed without correction several times according to [REDACTED]. The resulting breaking away of the manifold would have created an open path for fuel and vapors to enter the engine compartment.

1. The area of origin for this fire is on the top and right of the engine.
2. The manifold appeared to have broken away from its mounts.
3. The extensive fire damage to the remainder of the engine compartment deterred the possibility of the exact cause of this fire.

View of damage to intake (note front and mounting bolt).

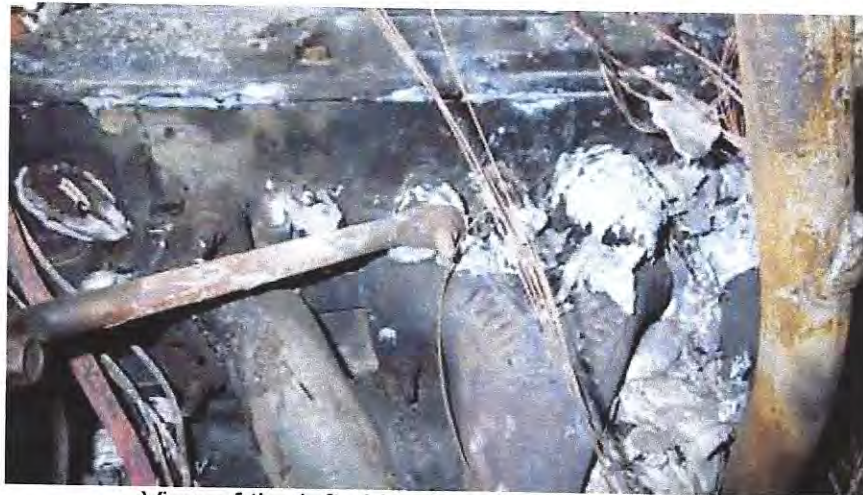
The examination of the fire damage revealed that a fire occurred in the engine compartment, specifically on the left side. Due to the flammability/combustibility of the engine fluids and available fuels, the damage sustained was severe.

A possible hypothesis for the cause of the fire may be the result of a hot surface ignition. There was evidence of oily residue spots over the engine parts on the left side. It should be noted the power steering lines were not in place and were burned away. There was no evidence of an oil leak in the front of the engine.

1. The area of origin for this fire was determined to be the engine compartment.
2. The point of origin could not be determined due to the lack of information and severe fire damage.
3. A possible hypothesis for the cause of the fire was noted in the above discussion section.
4. After a complete investigation of this fire loss, Trident has determined this fire to be undetermined in nature.

View of the left side of engine area of origin.

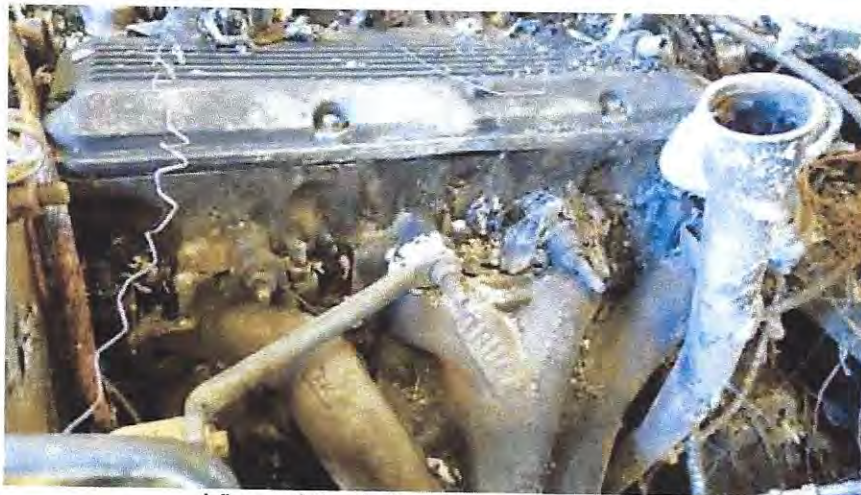
The examination of the fire damage revealed that a fire occurred in the engine compartment. The fire extended from the exhaust manifold and into the engine and passenger compartments. Witness accounts report hearing a noise and losing power steering. Shortly after, the witness reported seeing black smoke. The power steering pump/line sprayed/atomized fluid over the heated exhaust manifold, causing a hot surface ignition and creating the fire.

1. The area of origin for this fire was determined to be the engine compartment.
2. The point of origin was determined to be the exhaust manifold.
3. A leak from the power steering pump caused power steering fluid to spray on to the hot exhaust manifold.
4. The fluid leaked or sprayed onto the heated exhaust manifold caused a hot surface ignition and ignited available combustibles.
5. After a complete investigation of this fire loss, Trident has determined this fire to be a mechanical failure.

View of the left side point of origin.

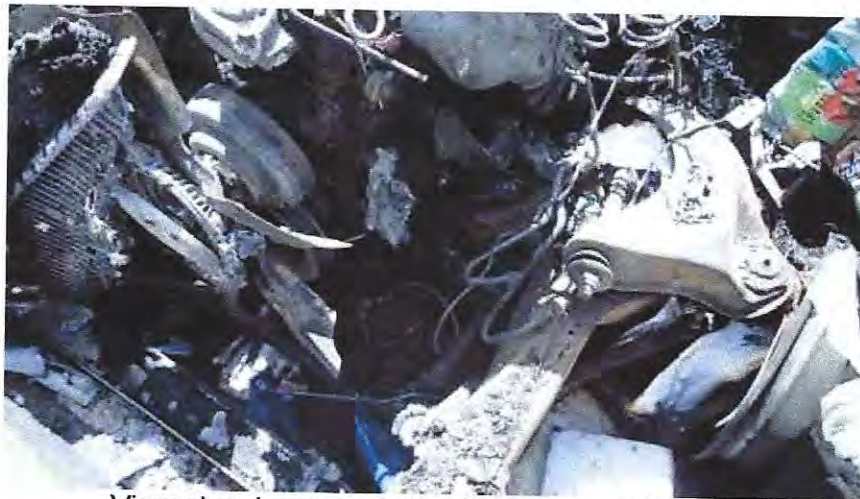
Examination of fire damage to this vehicle found the longest duration of burn occurred on the left front of the engine compartment. At this point, the power steering pump was found missing with extensive damage to the pump mounting bracket. As stated a search of the vehicle and the loss location failed to discover the power steering pump. With the missing pump in the area of origin, it is probable it was involved in the initial failure, however, without the unit to examine it is not possible to determine the first failure.

1. The area of origin is the left front of the engine compartment.
2. The power steering pump was not found in place.
3. The mounting bracket for the power steering pump revealed extensive heat damage.
4. With the missing component in the area of origin an exact point of origin cannot be determined.

View showing power steering pump not in place.

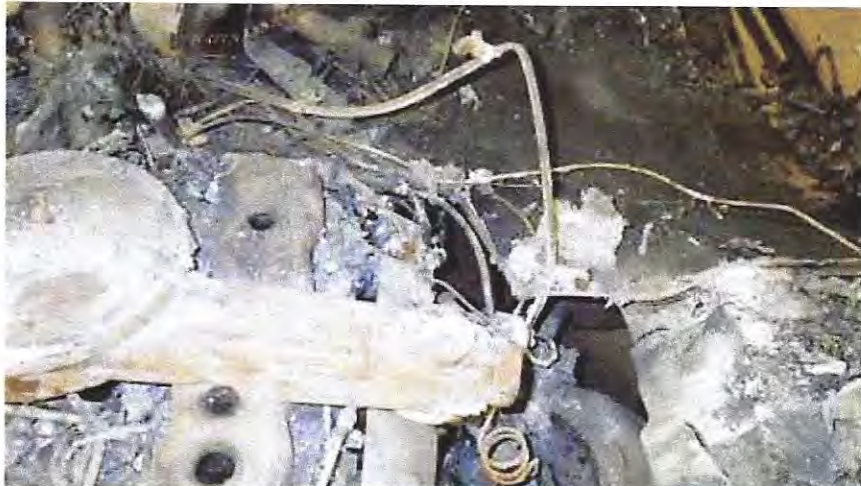
The examination of the fire damage revealed a fire occurred in the engine compartment, specifically on the left side, closest to the firewall.

A possible hypothesis for the cause of the fire may be the result of an electrical failure. The fact the heater blower motor was not working properly and would work intermittently when hitting bumps would indicate a short in the wiring. Also, the blower motor stopped working prior to the fire starting.

An electrical short behind the dash or heater blower motor could not be ruled out as a possible ignition scenario. It was reported that the blower motor worked on one speed and the lights also flickered after the blower motor stopped working. This along with an odor of electrical wires burning would support this scenario.

1. The area of origin for this fire was determined to be the engine compartment.
2. The point of origin could not be determined do to the lack of information and severe fire damage.
3. A possible hypothesis for the cause of the fire was noted in the above discussion section.
4. Because there is more than one possible hypothesis, the cause of the fire must be listed as undetermined.

View of left side damage Area of Origin.

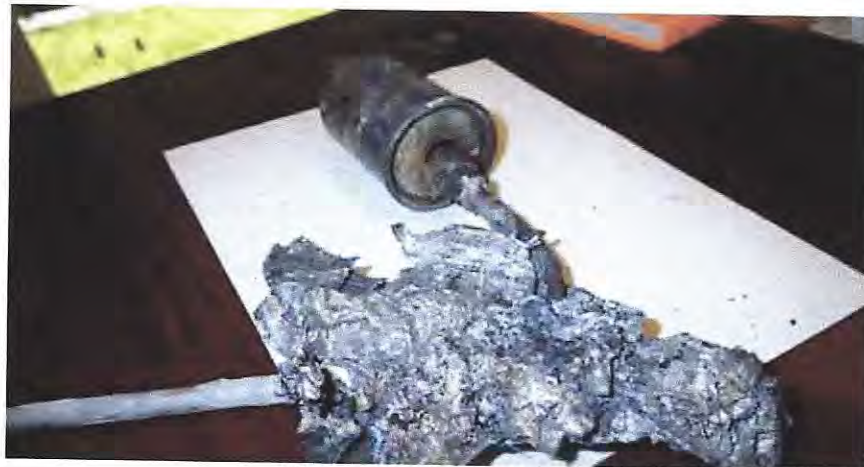
The examination of the fire damage revealed a fire occurred in the engine compartment, specifically the left side. Due to the flammability/combustibility of the engine fluids and available fuels, combined with an extended extinguishment time, the fire consumed all available combustibles in this area.

A possible hypothesis for the cause of the fire may be the result of a hot surface ignition. The fact that the carrier smelled gasoline, combined with a fluid trail, would indicate a gasoline leak. Also the fuel filter and broken pipe recovered at the scene and maintained by USPS staff, would further corroborate the above facts.

A fuel leak with the filter mounted on the front of the engine would spray gasoline on to the hot exhaust manifold. This along with an odor of gasoline would support this scenario.

1. The area of origin for this fire was determined to be the engine compartment.
2. The point of origin could not be determined due to the lack of information and the severe fire damage.
3. A possible hypothesis for the cause of the fire was noted in the above discussion section.
4. Because there is more than one possible hypothesis, the cause of the fire must be listed as undetermined.

View of fuel filter break.

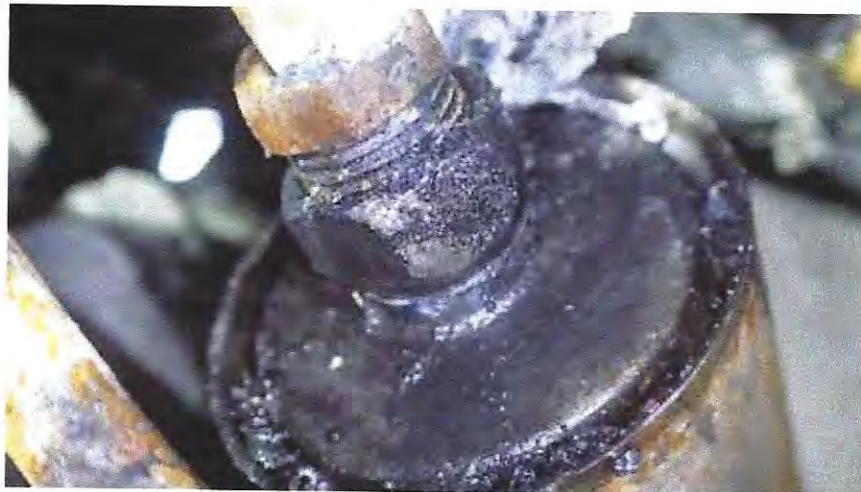
The examination of the fire damage revealed a fire occurred in the engine compartment, specifically the left side.

A hypothesis for the cause of the fire may be the result of a hot surface ignition. The fact that the carrier smelled gasoline would indicate a possible gasoline leak. Also the fuel filter having a loose fitting would further corroborate the above facts.

A fuel leak with the filter mounted on the rear of the engine would spray gasoline over the hot exhaust manifold. This along with an odor of gasoline would support this scenario.

1. The area of origin for this fire was determined to be the engine compartment.
2. The point of origin was determined to be the fuel filter.
3. A possible hypothesis for the cause of the fire was noted in the above discussion section.

View of fuel filter leak point.
